The Hong Kong Cricket Club Ground Reconstruction

Ground Reconstruction Project

- During the winter of 2004, a proposal was made to fully reconstruct the ground
- Increased membership, increased usage
- The existing surface had provided good service and had reached it's used by date

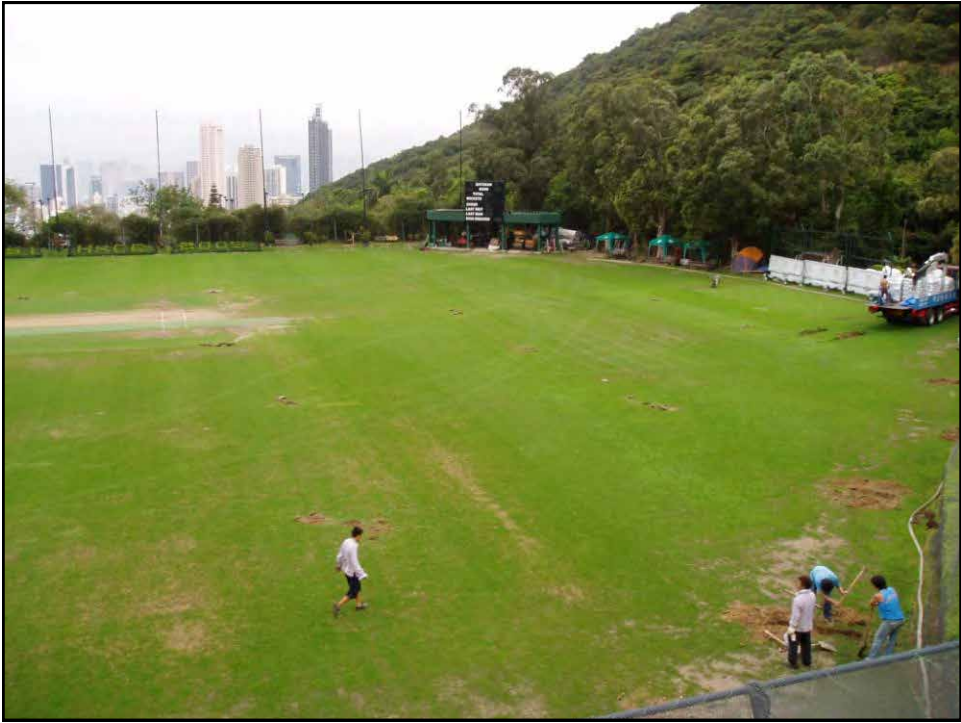
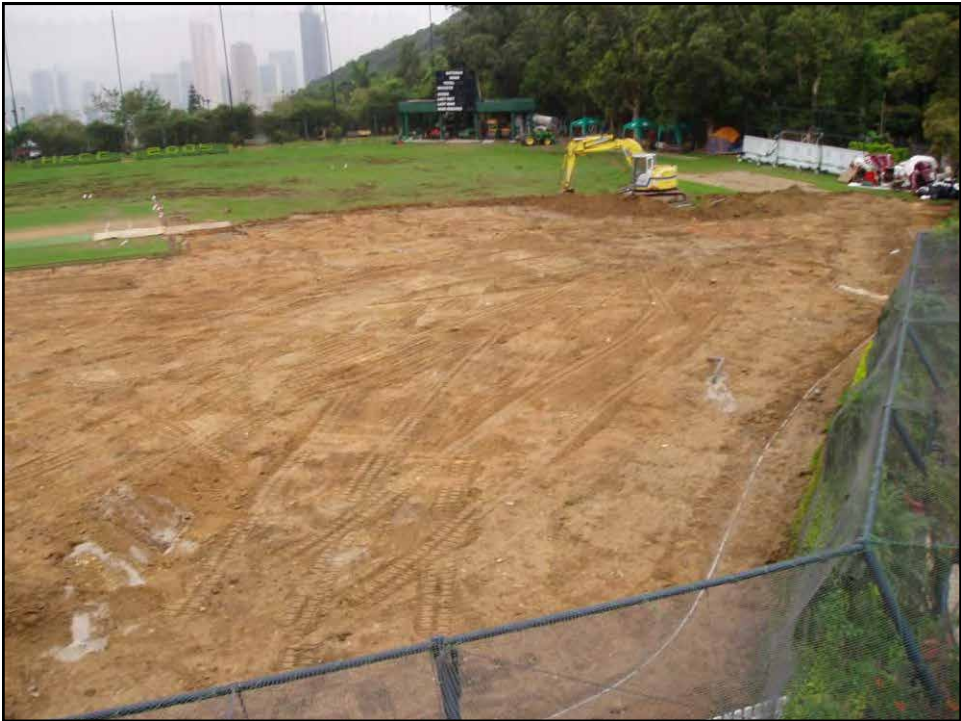
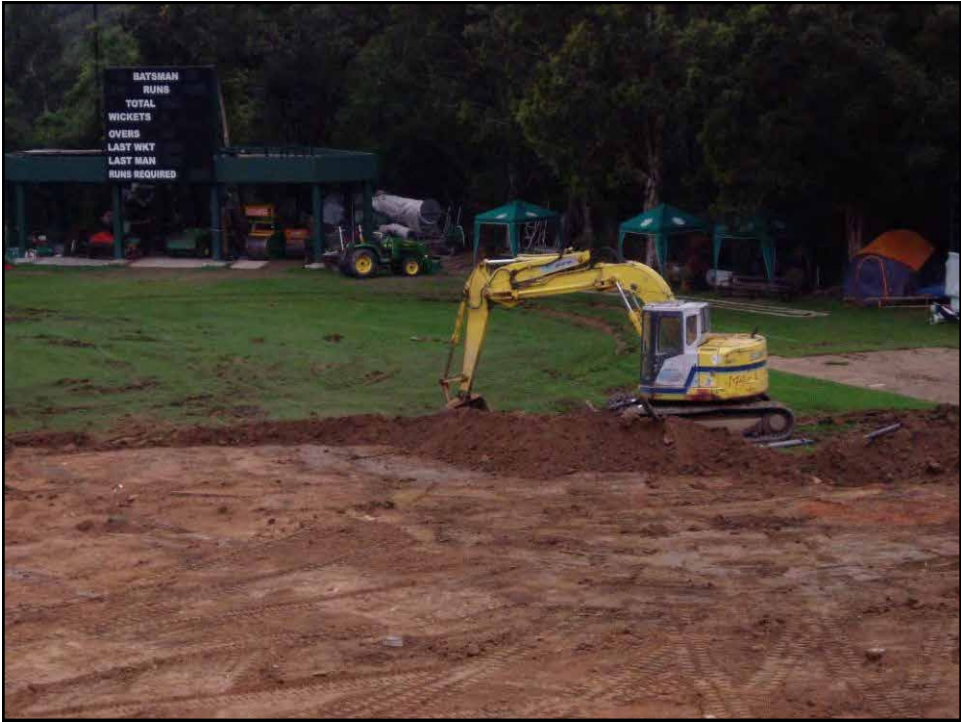
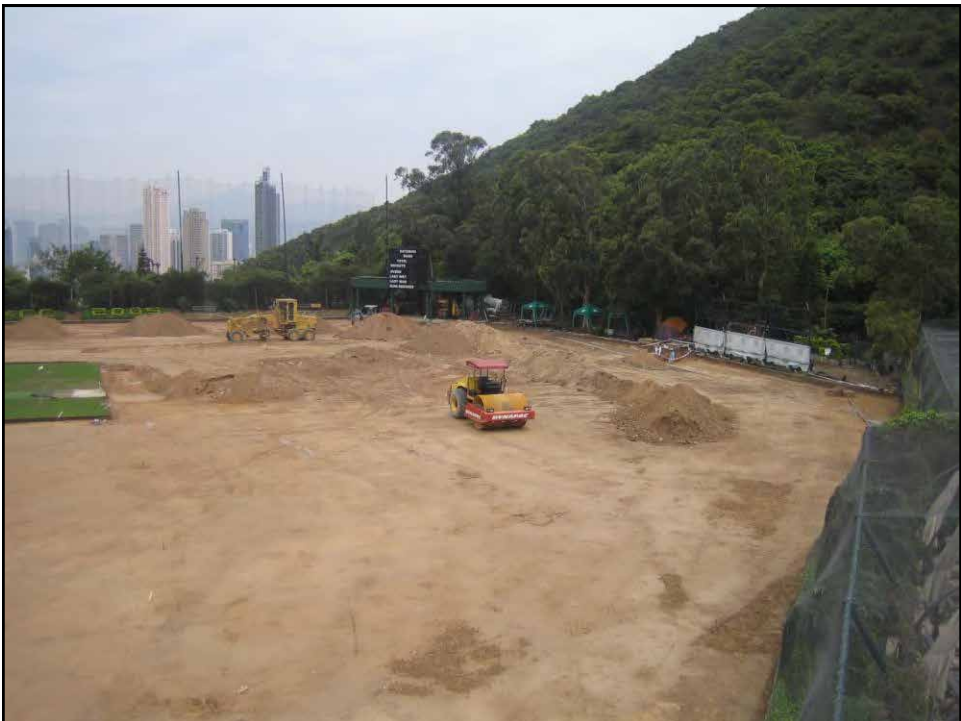
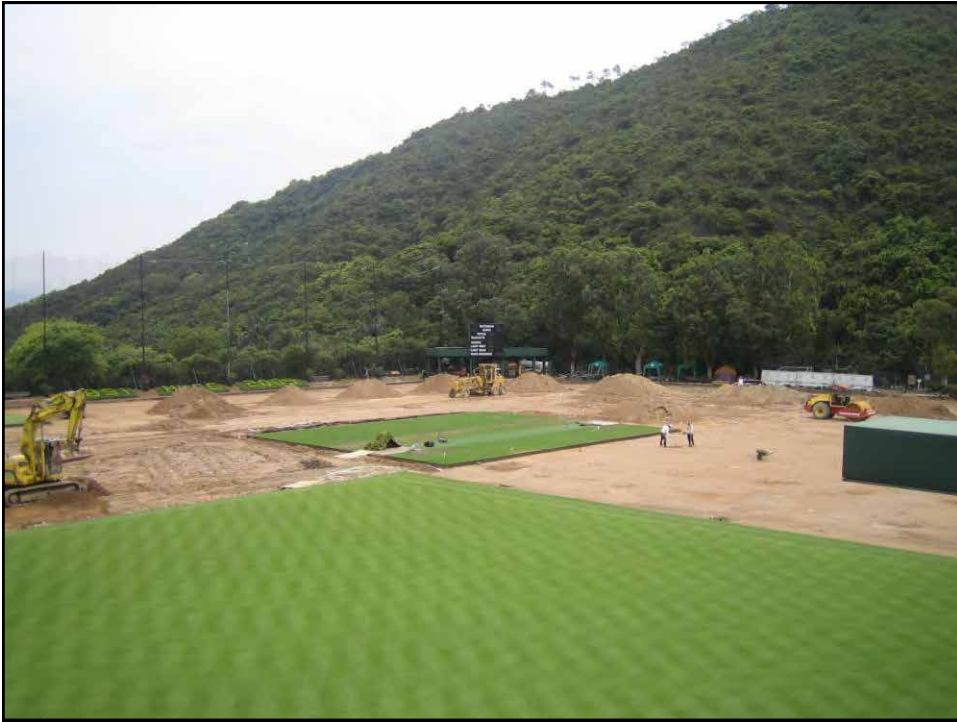
- Three month contract period
- The lawn Bowling Green & Cricket square was not included
- 2500m³ of soil excavated and taken off site
- The sub-base was shaped to have a 0.5% fall

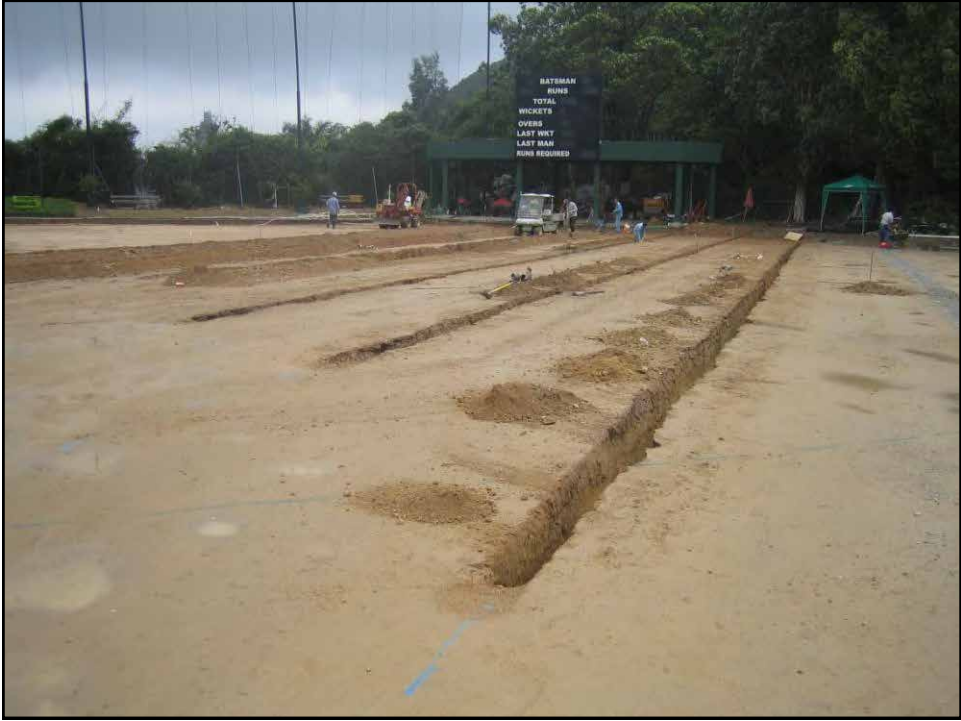
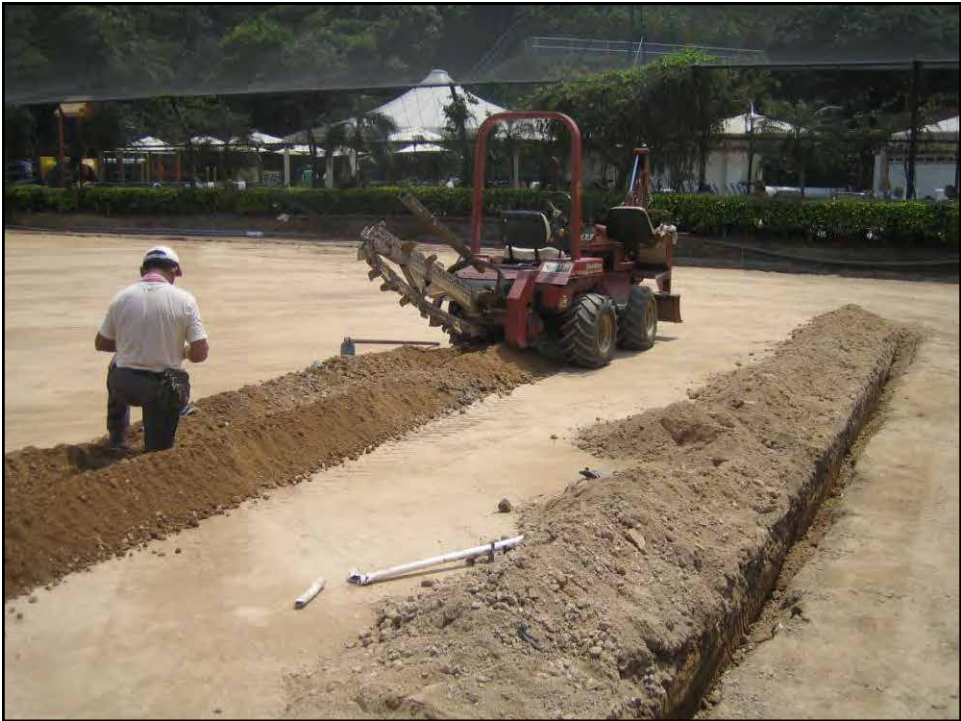
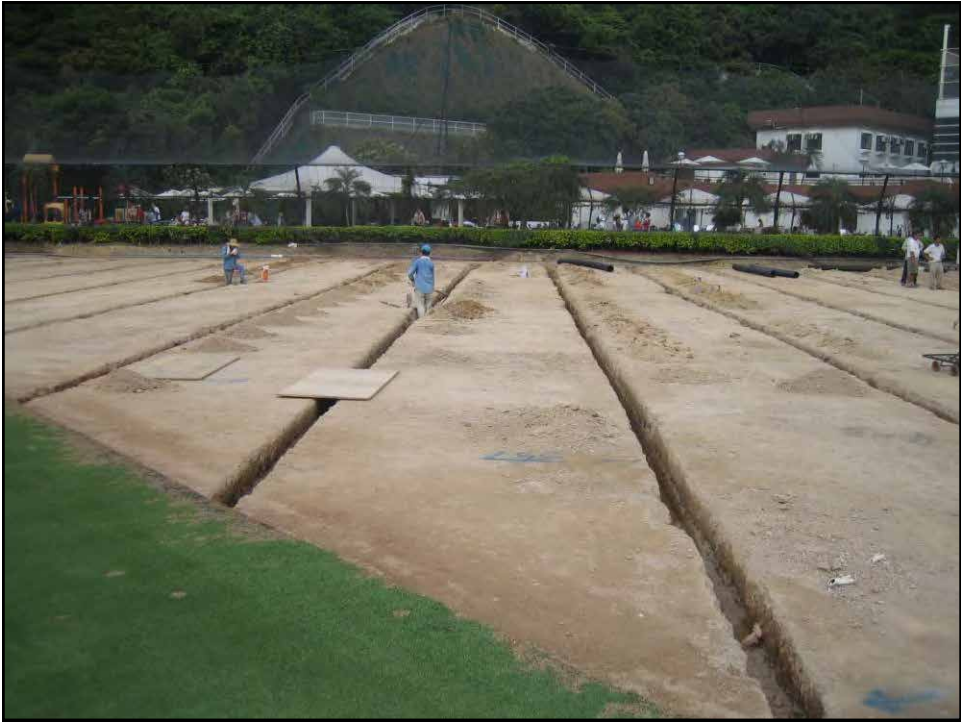
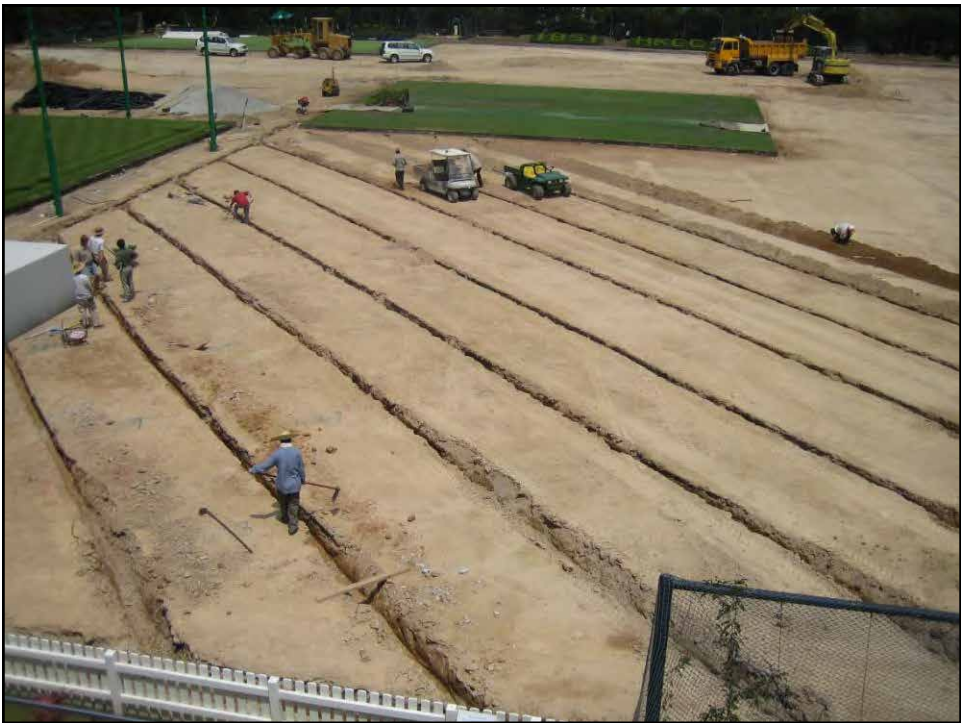
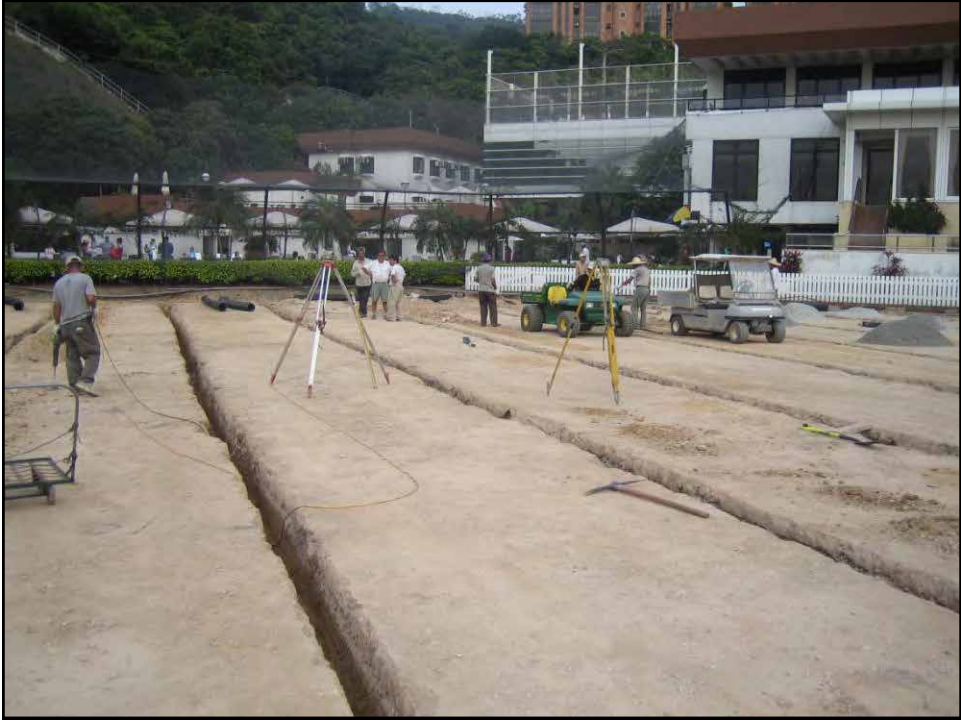
- The drainage was 'cut in' to the sub – base at 45 degrees & backfilled with 5-7mm aggregate
- Lateral pies were 100mm ADS Perforated pipe, Collector drain was 200mm ADS Perforated pipe
- All trenches and pipes were individually checked to ensure right falls

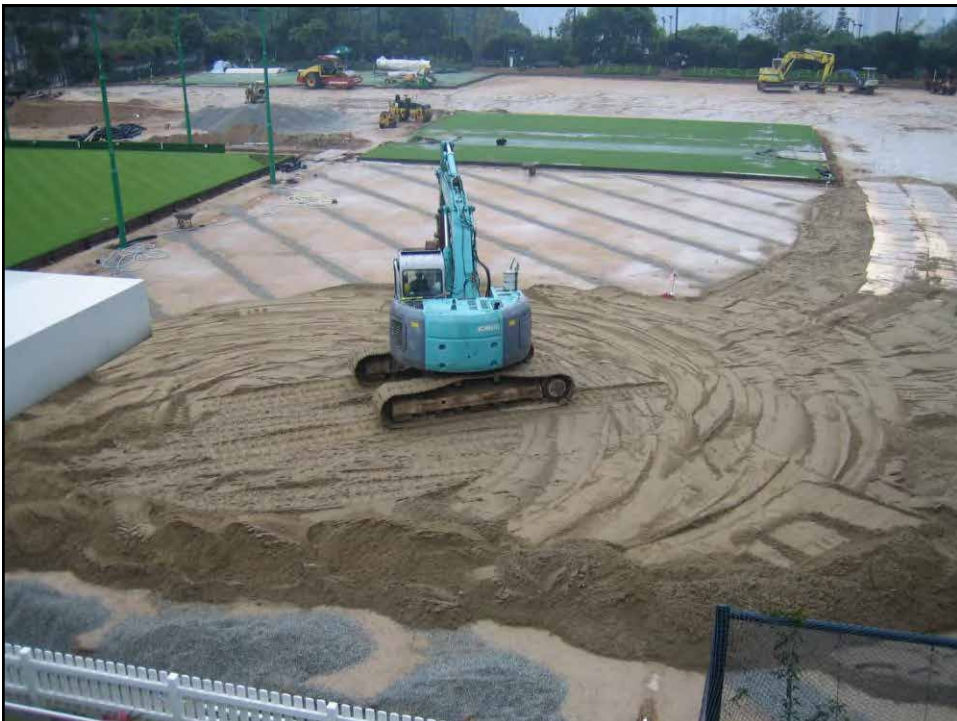
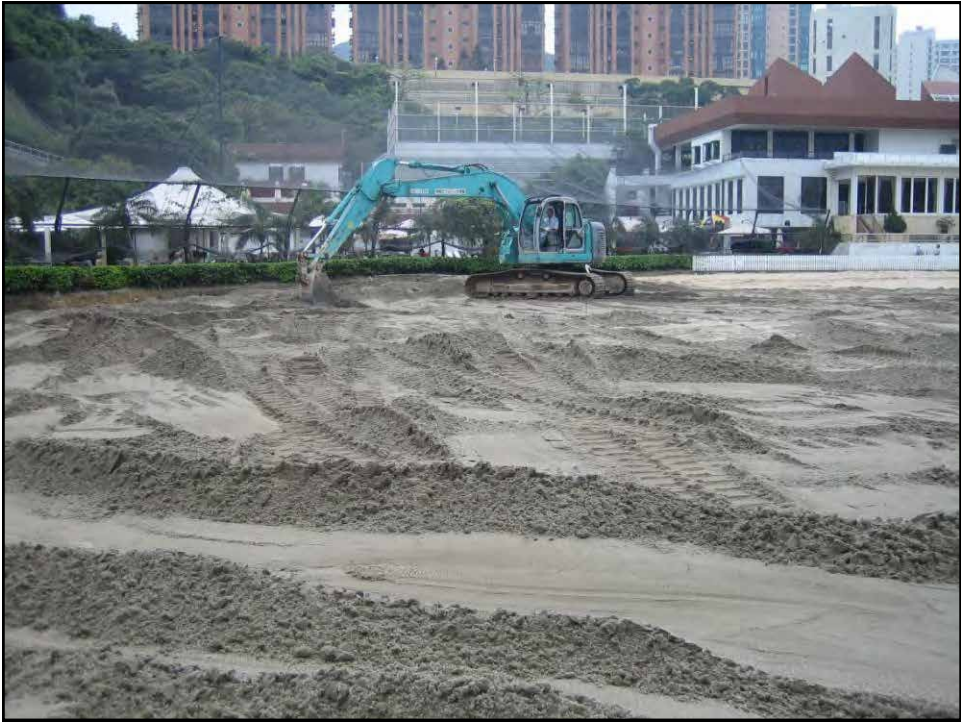
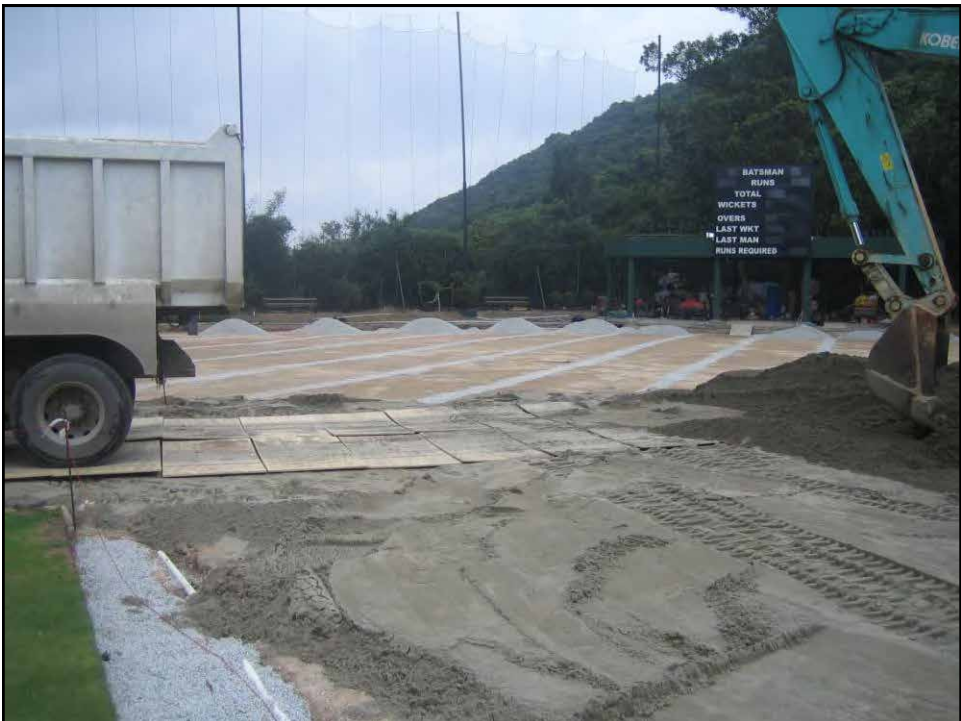
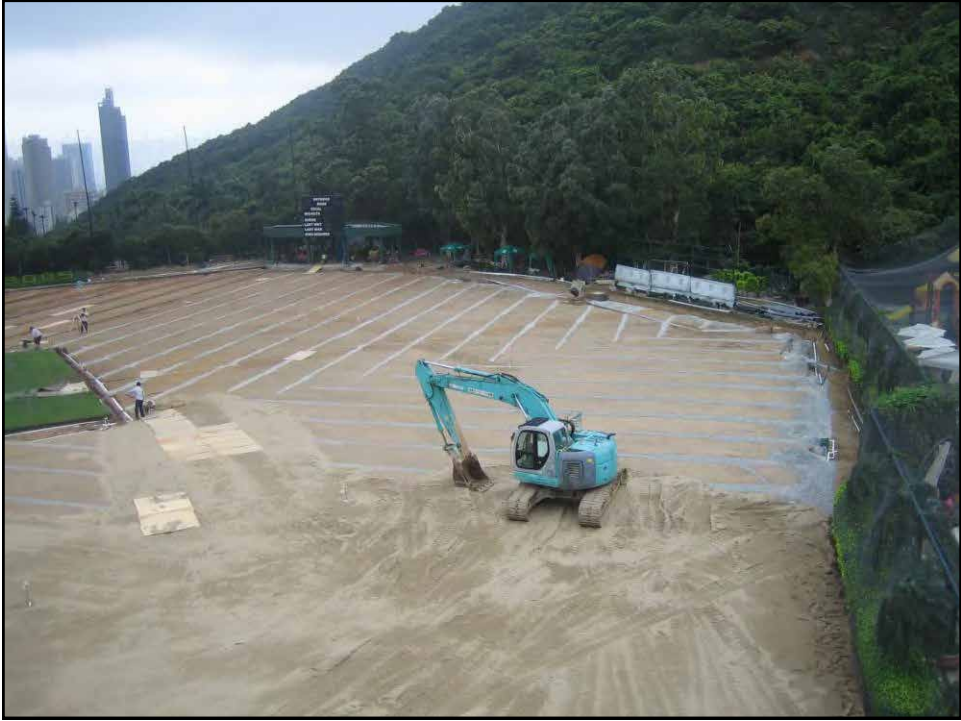
- Growing medium laid in two 125mm layers
- Bottom layer unamended, top layer amended
- Consolidated by both machinery & Irrigation
- Final leveled mirrored the sub-base falls
- Finished with excavator

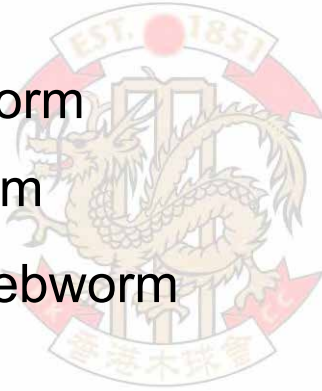
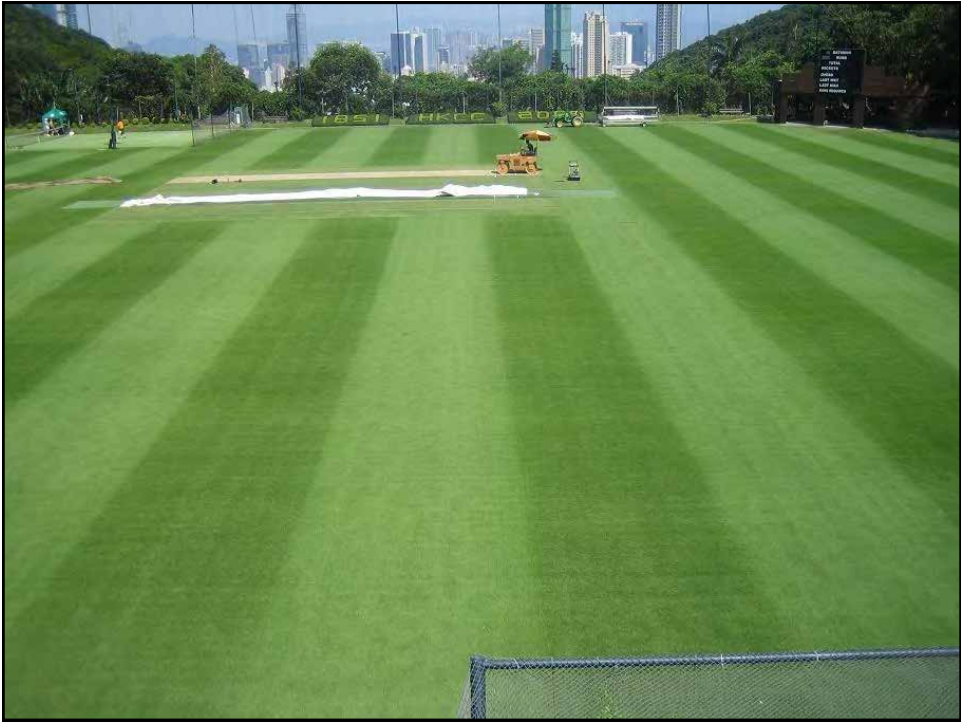
Insect damage has been excessive

- Bill Bug
- Armyworm
- Cutworm
- Sod Webworm

- Progress has been slow in first year
- Wear tolerance has not met expectations
- Density has been below Par
- Long Dormancy
- Machinery damage
- Isolated wear areas
